UNDERWATER FACILITIES AND INSPECTIONS AND ASSESSMENTS

NAVAL AIR STATION

PENSACOLA, FLA.

JANUARY 1983

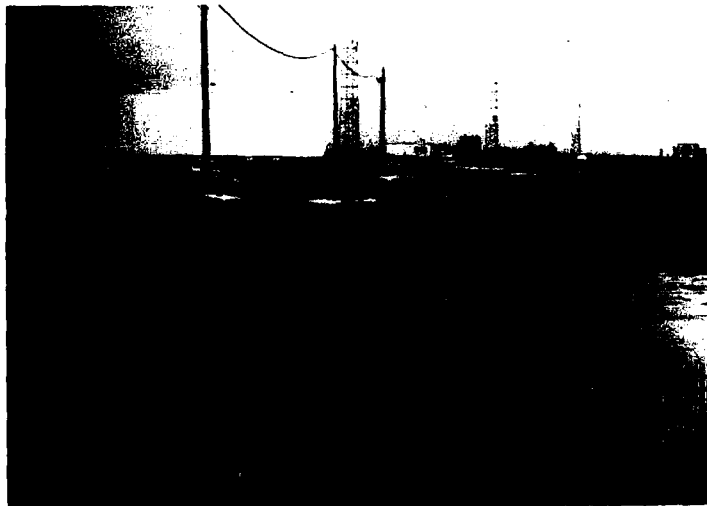
PHOTO NO. 22

Bulkheads 177,178 - View of wetface of bulkhead
above waterline opposite Finger Pier 303.
